Pulling the Plug on Corrosion

By Todd Hart

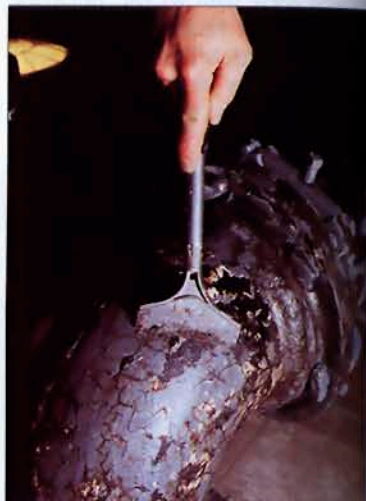
Steel in non-immersed areas was commercially blasted to SSPC SP-6 standards to obtain the proper surface profile.

All steel below the waterline was abrasively blasted to SSPC SP-10 near white standards, leaving a 2 mil profile. Care was used when blasting to avoid "peaks" in the profile that could protrude through the coating. The concrete in the same area was brush blasted to remove all oil, grease, dirt, dust and loose particles. Small bug holes, voids, cracks and air pockets were filled with an epoxy resin. In non-immersed areas, SSPC SP-6 commercial blast was utilized. To comply with EPA and OSHA mandates, areas with lead paint were sectioned off and all blast material was reclaimed for proper disposal.

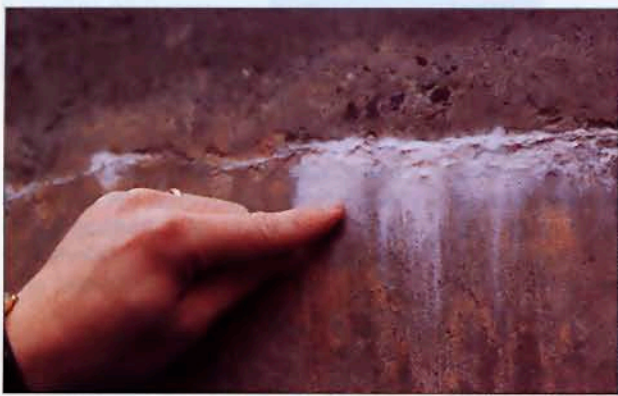
Sulfuric acid and hydrogen sulfide generated by the sewage treatment process caused extensive corrosion, including damage to the concrete walls evident in calcium staining on the exterior of the clarifiers.

Concrete that formed the outer basin of the two treatment units was badly pitted and spalled. Structural steel for the catwalks, railings, roof supports and the clarifier was also corroded. The deterioration was particularly severe at and above the waterline, where the coating had blistered and peeled. In addition, on large portions of the concrete and steel surface areas, the coating was completely absent. This was caused by sulfuric acid and hydrogen sulfide generated by the sewage treatment process. On the tank exteriors, calcium staining was prevalent, indicating water penetration through the concrete walls. Without corrective action, the integrity of the tanks would be severely impaired, leading to leaks, service interruptions and ultimately, complete structural failure.

After conducting a comprehensive site assessment, Mike Harrington, P.E., from Lamont, VanDeValk presented Smith with the recommendations. At the top of the priority list was the need to make concrete repairs. Loose concrete at spalled and delaminated areas had to be removed and filled with a cementitious repair compound. For long-term corrosion protection, new coatings would have to be applied to all steel and concrete surfaces in both plants. However, what remained of the original coal tar coating would have to be first removed, and both substrates properly prepared. Harrington also discovered a red lead coating on structural steel in

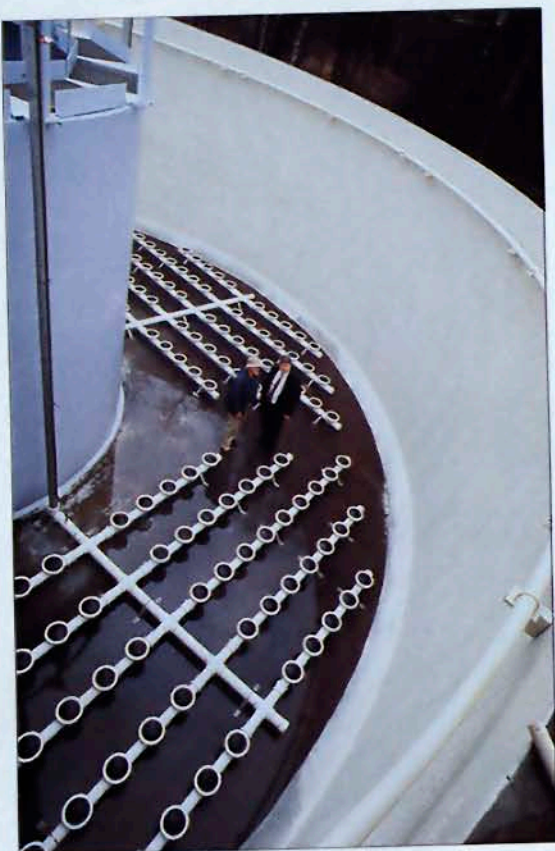
Course bubble diffusers were replaced with PVC piping and fine bubble diffusers to enhance aerator biological decomposition efficiency.

Not all of the suggestions made by Harrington involved maintenance issues. With tougher regulations on effluent quality expected, it made sense for Speculator to implement certain process upgrades during the rehabilitation project. Harrington focused his attention on the antiquated aeration basin. By removing coarse bubble diffusers and replacing them with PVC piping and fine bubble diffusers from Aerco Corporation, aeration biological decomposition efficiency could be enhanced. In addition to

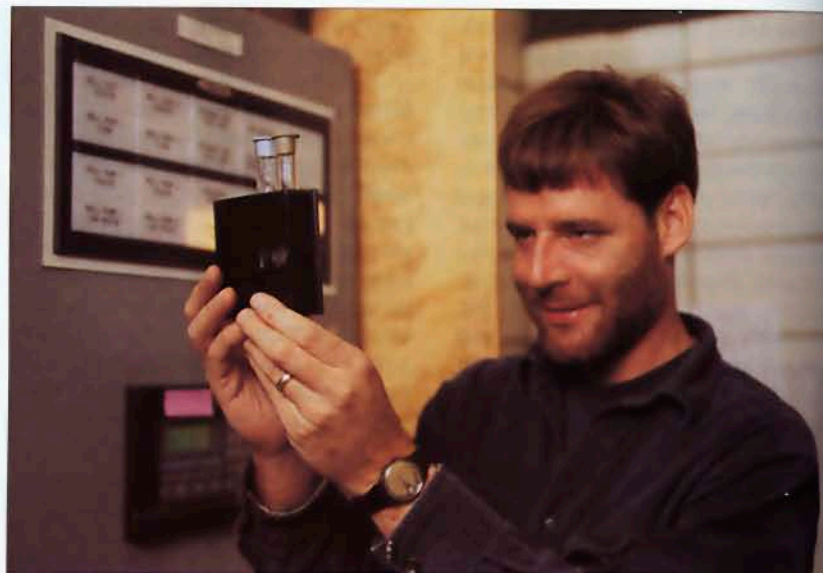
Improvements made to the treatment plant allowed Speculator to achieve 97-99 percent BOD reduction.
