# A Complete Solution

Pretreatment ensures sporting club's UV system operates effectively

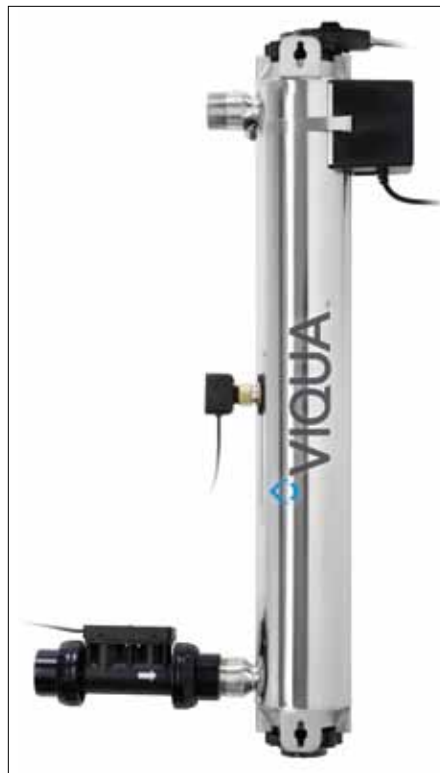
The sporting club's treatment system included a Viqua Pro UV unit.

Most UV water treatment products certified to NSF/ANSI Standard 55 Class A are optimized and calibrated for operating at a fixed maximum flow rate. This makes sense for larger systems, where the flow is unlikely to fluctuate drastically. With smaller systems, like the one installed in the sporting club, the flow was far from consistent. To overcome this, a subsequent upgrade to the UV system was needed—one that could recognize when there was less-than-maximum flow. The suggestion was to add a flowmeter to the Viqua Pro UV unit. The custom-engineered flowmeter offers real-time dosing and fail-safe flow detection. By measuring the actual flow instead of assuming it is a fixed rate, the system tracks UV dose in the chamber.
