tech update pou

Water filtration system provides Amazon villages with cleaner water group of 400 native Peruvian Amazonians known as the Maijuna desperately searched for answers to help reduce their high child mortality rate when it became clear that their drinking water was one of the major culprits.

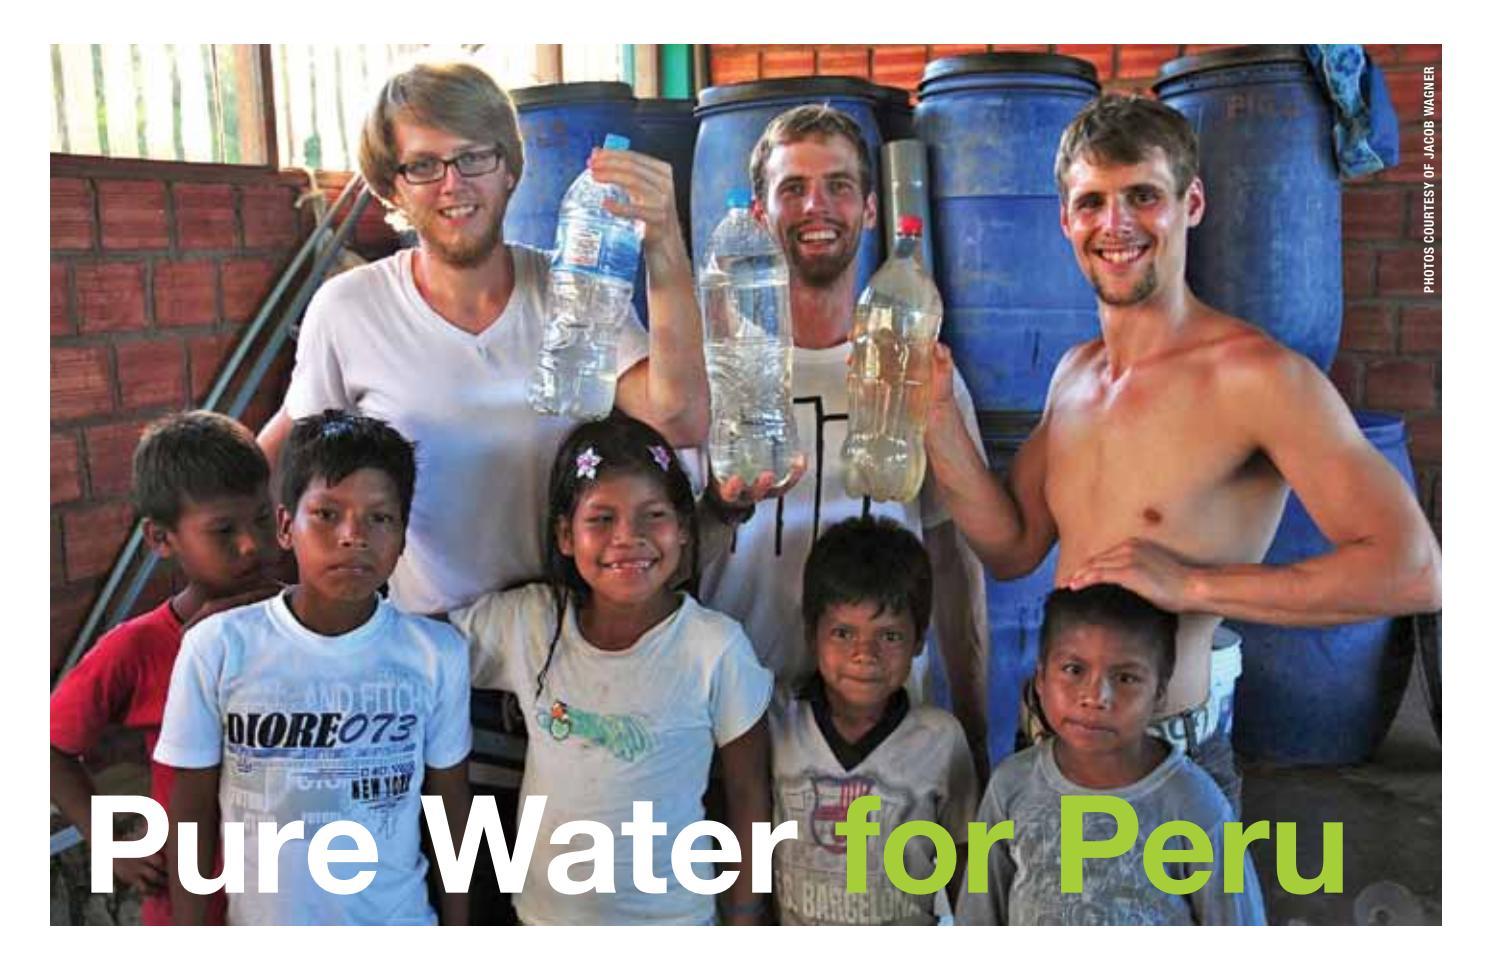
Student travel team GMU-EfID members Laurence Benson, Robert Burkart and the author, Gabriel Stonebraker, hold results from the biosand filter test. From left to right, they hold purchased bottled water, filtered river water and unfiltered river water.

The travel team built a biosand filter with the sand collected by the Maijuna, then ran tests on the filtered water with a turbidimeter and saw dramatic results. The team compared raw river water to filtered river water and purchased bottled water. The raw river water's turbidity was approximately 35 ntu; the filtered river water at its lowest was 3.04 ntu; and the purchased bottled water was 2 ntu.

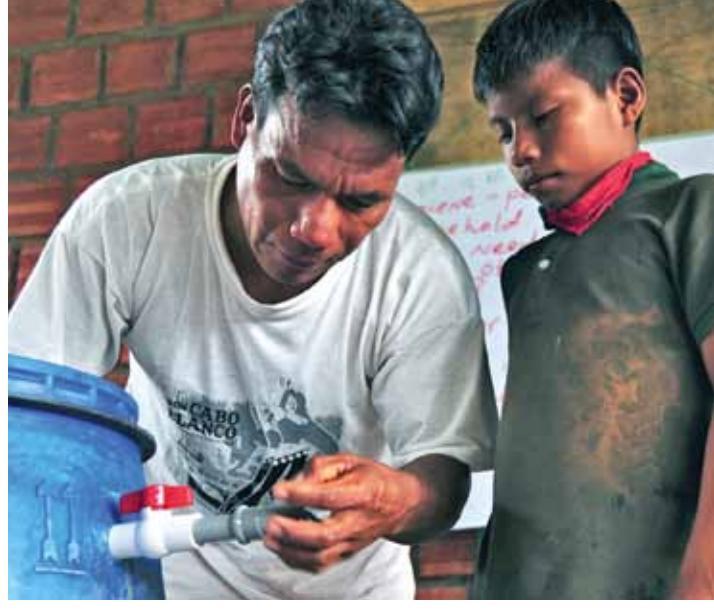
Maijuna community members Billy and Douglas put together a biosand filter.

Biosand filters are low tech and can be made with materials that are readily available to the Maijuna. A 30-gal food-grade plastic drum houses the filter medium. Pipe and fittings are placed inside the housing and medium, and exit near the top of the plastic drum, below the upper lip.

The pipe and fittings are first assembled and placed inside the plastic drum. A 10- to 20-cm layer of gravel is placed inside the container, followed by a 50- to 100-cm layer of sand. Water then is placed inside the

barrel until the water level reaches just below the tap fitting of the pipe system. The system requires no pumps or mechanics to pump the water out of the filter; it relies on pressure head from the water level.
